LARGE-SCALE TESTS OF FLAME
SPREAD ON ROOF BUILD-UPS
WITH PV SYSTEMS: PHASE I

11/2025

Case number: SIEC21006
Report number: 21006-001

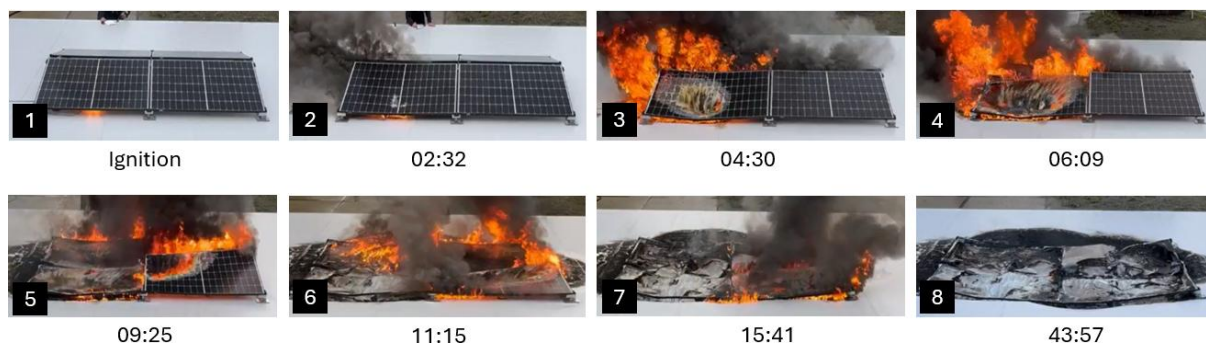
In all four tests, the roofing membrane near the gas burner ignited within the first minutes after test initiation, as seen in the video frames from test 1 in Figure 7.1 to 7.2. Subsequently, radiative feedback, caused by flame deflection beneath PV1, heated the surrounding roof surface, leading to the release of combustible pyrolysis gases near the flame front [9], [14]. When the concentration of these gases exceeded their lower flammability limit, an additional area of the roof surface beneath PV1 ignited.

Focusing initially on three of the four tests (tests 1, 3, and 4), self-sustained flame spread continued within the cavity between the roof surface and the four PV modules, as illustrated by eight video frames from each test in Figure 7 to Figure 9. This behaviour was also observed in previous large-scale tests of BAPV systems on flat roof construction build-ups. [11], [12], [13].

During the tests, failure of the mounting systems' aluminium profiles is observed, resulting in the collapse of the PV array onto the roof, as shown in Figure 7 to Figure 9 subfigures 5-6: because of this, available oxygen for the continuation of the combustion process is significantly reduced and, in conjunction with potential limited fuel left for combustion, self-extinguishment of the fire occurred.

Figure 7 – Flame spread pattern in test 1. The gas burner was turned off 10 minutes after the ignition. PV modules located in accordance with Figure 5. Thus, PV1 is seen above the gas burner and the module on the right side of PV1 is PV3

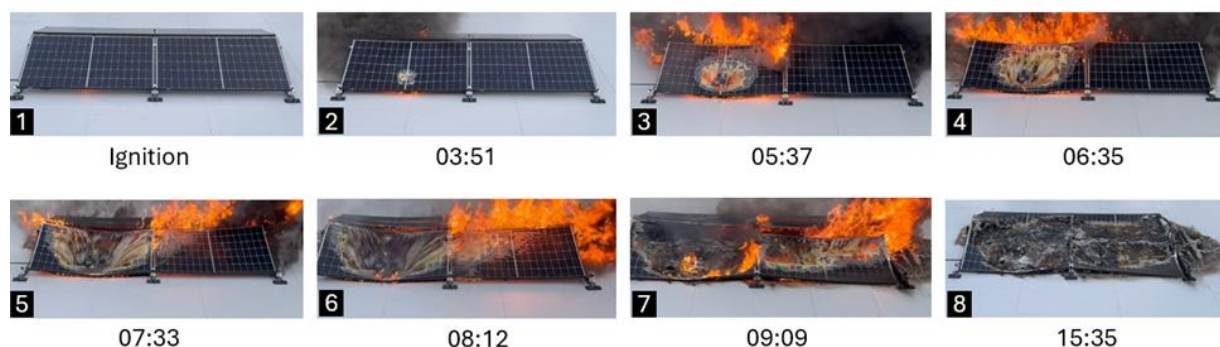
Figure 8 – Flame spread in test 3. PV modules located in accordance with Figure 5. Thus, PV1 is seen above the gas burner and PV3 is seen on the right side of PV1.

When comparing the flame spread process in tests 3 and 4 (Figure 8 and Figure 9), the overall trends in Subfigures 1–6 are similar. The slightly delayed flame spread in test 4, which was conducted with Bitumen rather than single-ply PVC, cannot be considered significant without test repetition. However, the overall test duration and combustion within the cavity were longer in test 4 due to the increased fuel load ascribed to the larger membrane thickness¹, and thus fuel load, of the Bitumen.

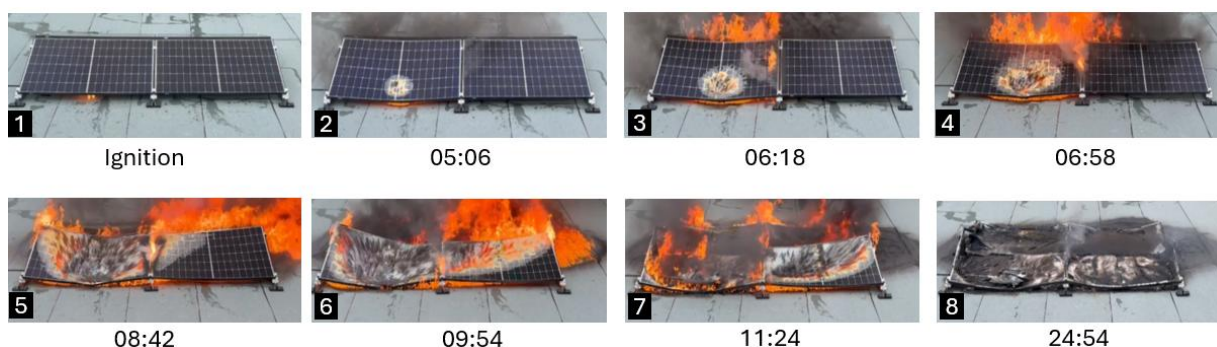
Figure 9 – Flame spread in test 4. PV modules located in accordance with Figure 5. Thus, PV1 is seen above the gas burner and the module on the right side of PV1 is PV3

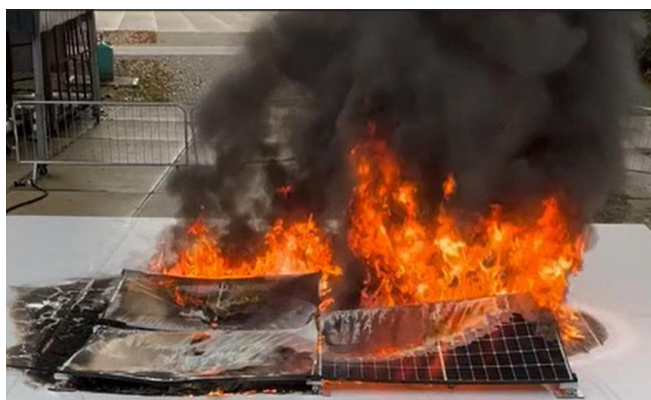
Figure 10 – Video frame from 10 minutes after ignition of test 1 illustrating the near vertical smoke plume caused by limited wind load.

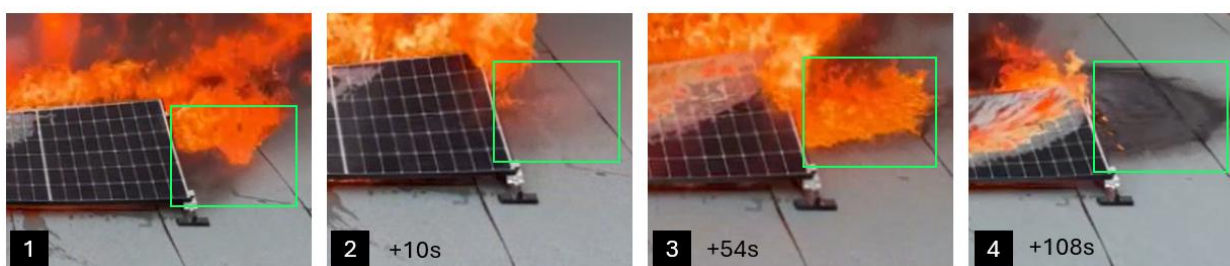
Figure 11 – Temporary ignition of the bitumen surface along the shorter side of the PV array in Test 4.

Without the radiative contribution from the deflected flames, the fire was extinguished as expected for a $B_{ROOF}(t1)$ -compliant single-ply PVC membrane or Bitumen roofing on an open roof surface. As the wind direction was shifting, with the wind load in tests 3-4 being higher than in tests 1-2, it is expected that the wind caused deflection of the flames along edges of the PV arrays resulting in temporary ignition of the roof surface.

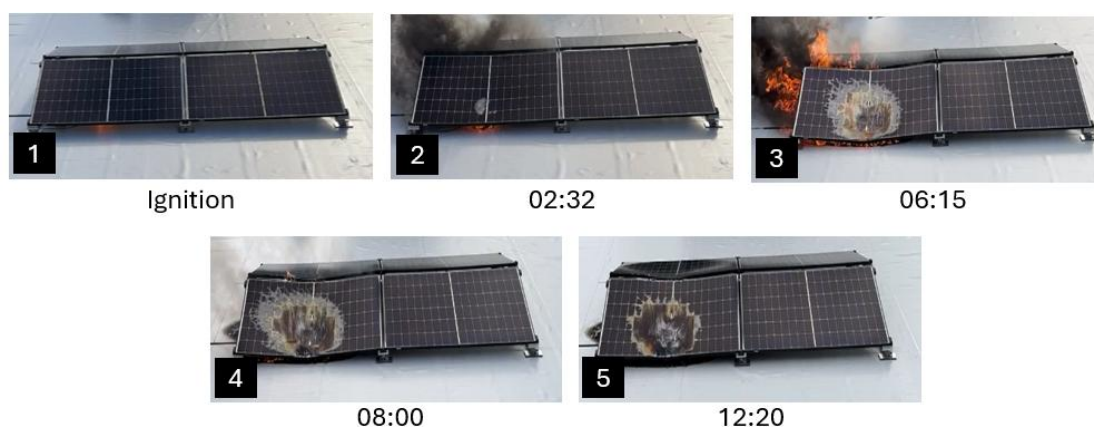
In test 2, which was an outlier compared to the other tests and similar large-scale experiments [11], [12], [13], flame spread was confined to the area beneath PV1, as shown in Figure 12. Like tests 1 and 3, the PVC membrane near the gas burner ignited, but no self-sustained flame spread occurred during the ignition phase of the tests. Since flame spread occurred along the same PVC membrane in tests 1 and 3, the varying input parameters across the three tests are examined to understand why the flame spread was significantly less severe in test 2.

Figure 12 – Flame spread in Test 2. Flame spread was limited to the area beneath PV1 only while the burner was active. Limited damage to the PV array and remaining roof area was observed. PV modules located in accordance with Figure 5. PV1 is seen above the gas burner.

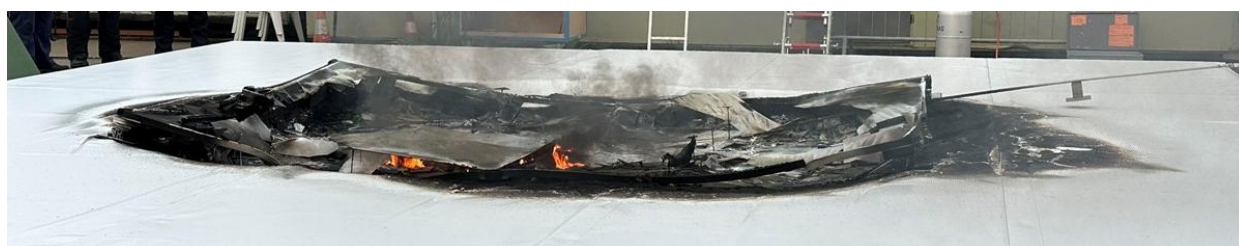
Figure 13 – From the end of test 1, where the EPS was initially ignited and subsequently melted below the PV array. The closest PV modules are PV4 (left) and PV2 (right) in accordance with Figure 5.

As mentioned in Section 2.1.1, the EPS was ignited in test 1 and all the EPS melted below the PV system as indicated from the level of the collapsed PV array in Figure 13. It is expected that ignition of the EPS occurred as the result of either mechanical or thermal failure of the double layered 1.2 mm thick glass-fleece installed between the surface of EPS and PVC membrane. After the initial ignition of the EPS, the adjacent EPS melted and retracted, which prevented self-sustained flame spread within the insulation material. Consequently, no water was used for extinguishment.

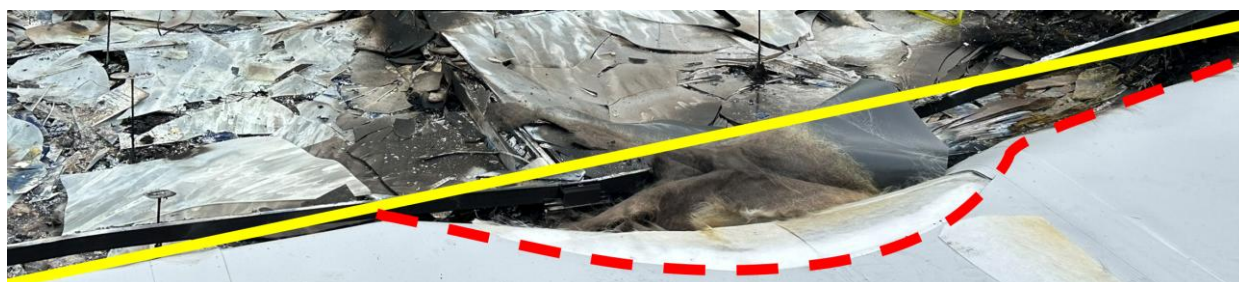
Figure 14 – From test 1. Yellow line indicates the original edge of the PV modules PV 4 and PV 3. The dotted red line marks the edge of melted EPS. Cutting of single-ply PVC membrane done by KIWA for the test report during inspection of roof damage.

In line with the horizontal flame spread pattern, the affected part of the roof construction was confined by the footprint of the BAPV array and as such, melted EPS was solely observed near the perimeter of the BAPV array as illustrated in Figure 14.

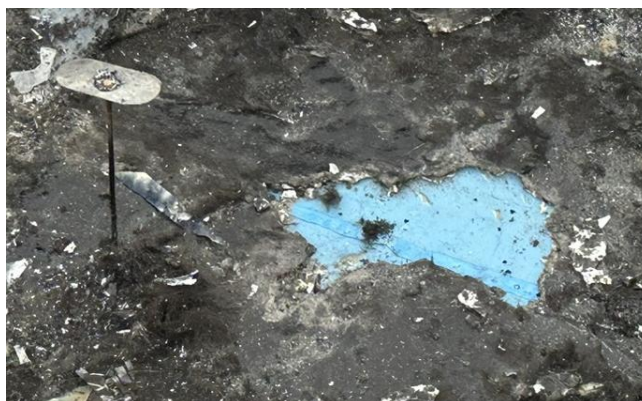
During KIWAs following examination of the roof built up below the BAPV array in test 1, the vapour barrier installed below the EPS insulation was found to be intact at the location examined, as illustrated in Figure 15. The intact vapour barrier indicates retraction of the EPS which at the examined location prevented self-sustained flame spread within the EPS. The remaining part of the roof was not examined on the test day, but afterwards the employees at Twente Safety Centre disassembled the roof build-up. No damage was observed at the trapezoidal steel deck as showed in Figure 16.

Figure 15 – From test 1. Intact vapour barrier observed below melted and charred EPS at the examined location.

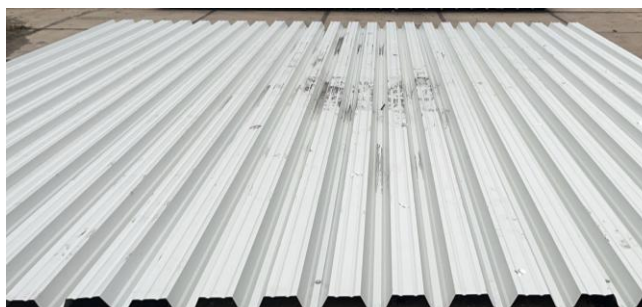
Figure 16 – From test 1. Trapezoidal steel deck after disassembly of the roof build-up. No residue from droplets formed by melted EPS noticed by the team at Troned test facility. From KIWA report.

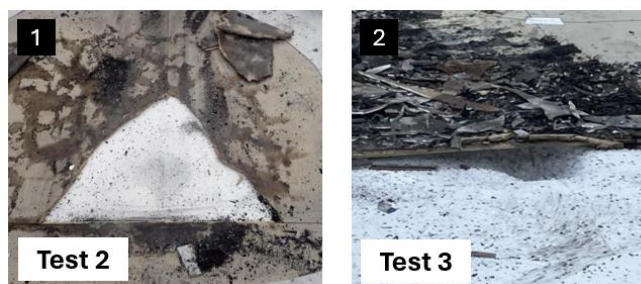
In both tests, the depth of the cavity was no more than 10 cm with a diameter lower than 20 cm as seen from the images in Figure 17. In both tests, gas burner was located above assemblies of the CPBs. In the final test, test 4 conducted with 8 mm of Bitumen membrane, no melted EPS was observed below the mitigation layer.

Figure 17 – Melted EPS insulation below the cement-bonded particle board. Notice that cavities were located below intersections between three (left) and two (right) boards.

As such, the tests indicated that the cavities within the EPS, caused by a local temperature increase, in tests 2 and 3 was the result of heat transfer from the gas burner during the ignition phase, rather than from the combustion process in the cavity between the roof surface and PV array.
