LARGE-SCALE TESTS OF
FLAME-SPREAD ON ROOF
BUILD-UPS WITH PV SYSTEMS:
PHASE II

11/2025

Case number: SIEC21006
Report number: 21006-002

In this report the Danish Institute of Fire and Security Technology (DBI) outlines the method and results of three large-scale tests conducted by IVH, the German Rigid Foam Industry Association and EUMEPS, the European Manufacturers of Expanded Polystyrene.

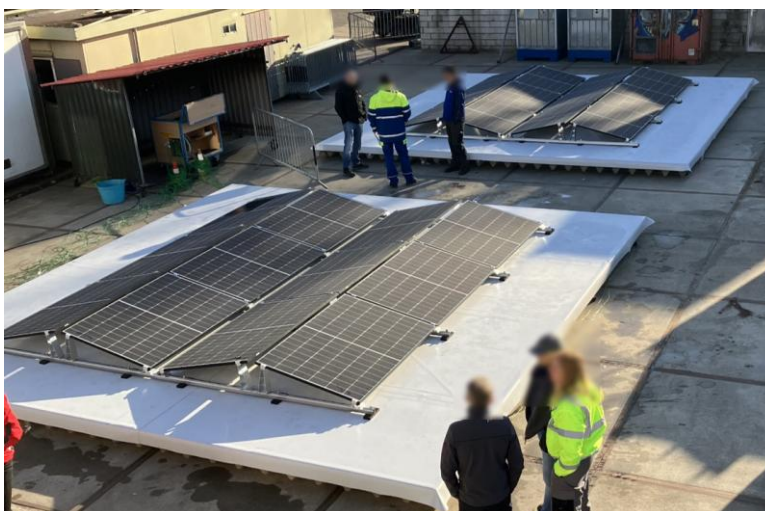
Figure 1 - Aerial view of the two roof construction build-ups used for tests 5-7.

Prior to the test day, two test setups were constructed in a designated test area located between several low buildings, as shown in Figure 1 and Figure 2. The surrounding buildings, primarily situated to the east and west of the test site, provided some shielding from potential wind effects. The tests were conducted sequentially, one at a time.

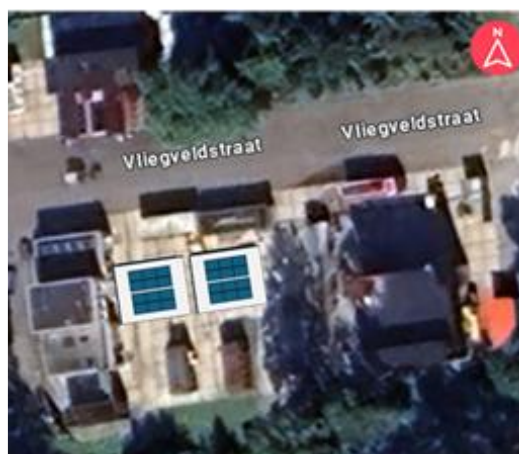
Figure 2 – Google maps screen shot of test location at Twente Safety Campus. The PV modules and indication of North is added to the screen shot.

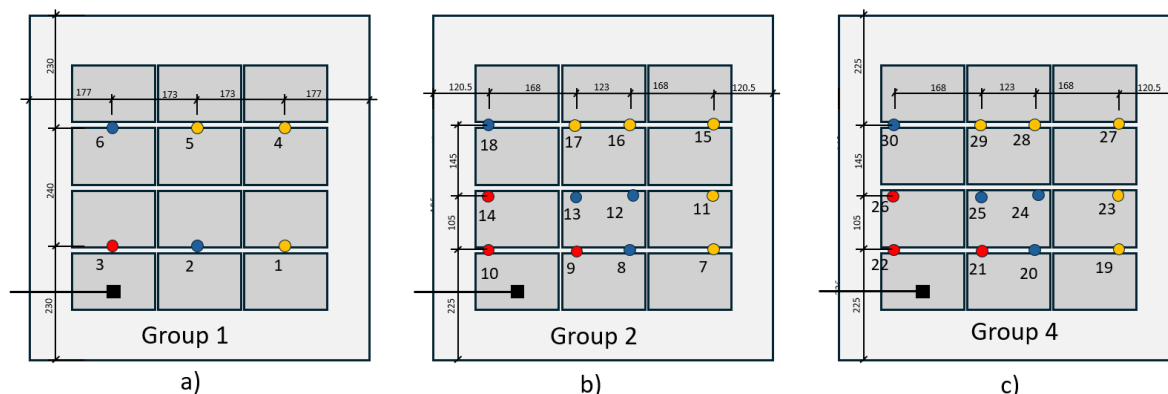
Figure 7 – Test 7. Thermocouple distribution across the three different measurement layers a) below the vapour barrier, b) in the middle of mineral wool, c) between mineral wool and the PVC membrane. Dimensions are given in cm and are approximate.

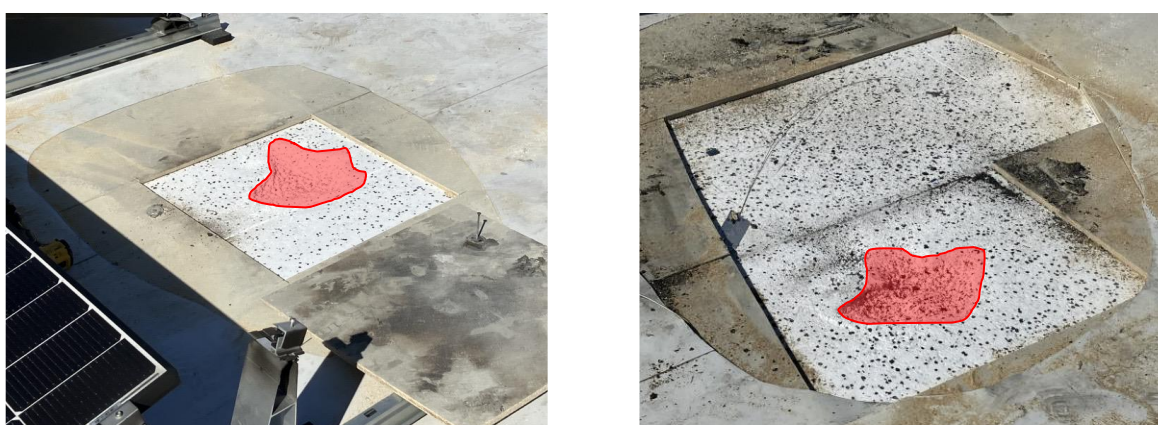
a) b)
 Figure 10 – Melted area of EPS under the cement-bonded particle board. **a)** test 5 **b)** test 6

Melting of the EPS insulation was observed on a limited area directly below the burner and comparable melted areas were seen in both tests (see Figure 10). The areas of melted EPS were limited to a diameter of approximately 25 cm in both tests and the melting indicates that the temperature of the boundary layer between the cement-bonded particle board and EPS insulation exceeded 100°C [7]. Comparing the outcome of tests 5 and 6 with test 2 and 3 from the previous phase of the project [1], the extent of flame spread was lower in test 5 and 6.

No matter the occurrence of self-sustained flame spread in the four tests, the area of melted EPS insulation in all tests were limited to a similar size area below the gas burner. Consequently, it can be concluded that the melting of EPS was caused by heat transfer from the gas burner flame, rather than the combustion of the PVC membrane in the cavity between the roof surface and PV modules.

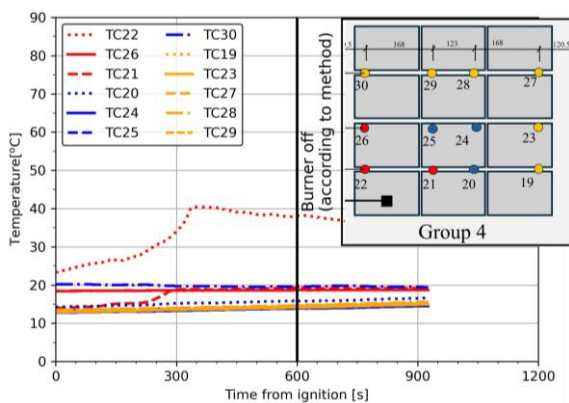
Figure 13 – Thermocouple measurements directly below the PVC membrane in test 5

Temperature measurements between the cement-bonded particle board (CPB) and PVC membrane in test 5 and test 6 are plotted in Figure 13 and Figure 14. Only a minor temperature rise can be observed below the roofing membrane in test 5 and test 6, as the thermocouples were not placed directly below the gas burner and there was no significant flame spread to the area of the roof construction near the thermocouples TC21 and TC22 in test 5, as well as TC29 and TC30 in test 6.

In test 5 the highest temperature is measured with TC22, located towards the opening of the cavity space between the PV panels. In test 6, on the other hand, the highest temperature was observed on TC 29, located deeper inside the PV array construction and in the downwind direction relative to the location of the burner. This corresponds with the increased damage of the PVC membrane observed in the downwind direction of test 6 (see Figure 11 b). The temperatures are lower, however comparable with those measured during the previous round of tests where no self-sustained flame spread occurred (i.e. test 6 in [4]).

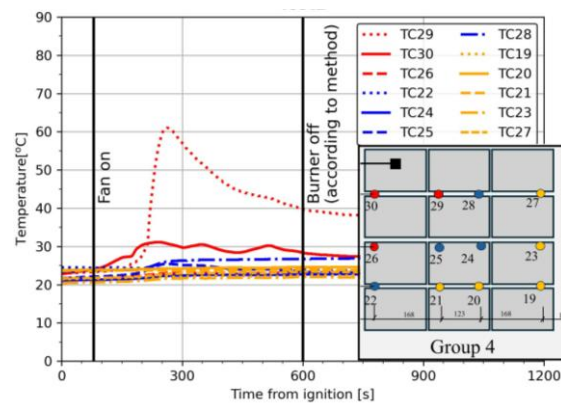
Figure 14 – Thermocouple measurements directly below the PVC membrane in test 6

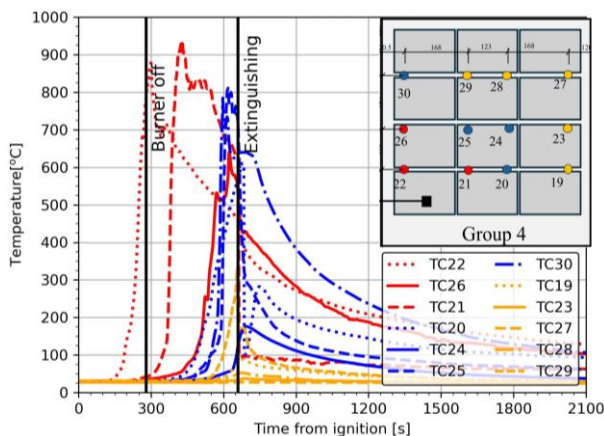
Figure 16 – Thermocouple measurements in test 7 below the PVC roof layer (TC group 4).

The temperature measurements for test 7 are plotted in Figure 16 to Figure 17. To some extent, the temperature readings allow the estimation of a flame spread rate in the cavity between the roof surface and the PV array. The flame spread rates, along with the distances between thermocouples and the burner, are summarized in Table 3.

For the purpose of this report the flame front reaching the thermocouple is defined as time when thermocouple measurement reaches 300°C during a relatively steep temperature rise. The critical temperature of 300°C is based on engineering judgement. It is difficult to determine an objective critical temperature, because the unburned PVC layer protects the thermocouples even after the pyrolysis zone has passed the above material. Considering the defined criteria the flame spread to PV3 at around 6th minute (the burner is already removed at this point) and to edge between the adjacent array (TC 26 and TC 30) at around 9th – 10th minute.

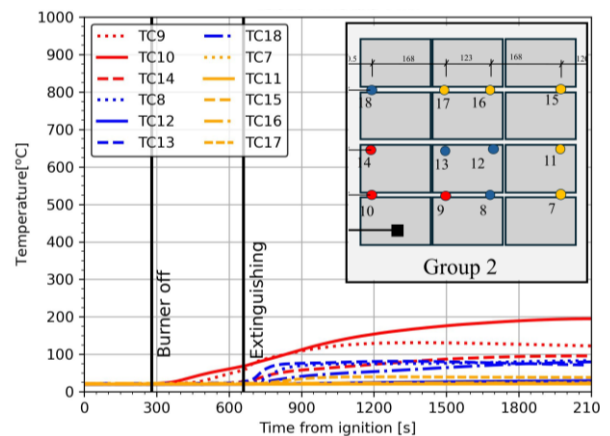
Figure 15 – Thermocouple measurements in test 7 inside mineral wool (TC Group 2).

The increase of temperatures inside the 120 mm of mineral wool starts rising at around 5th minute of the test where the gas burner is already turned off and removed. These temperatures keep rising long after the fire is extinguished to a maximum of almost 200°C. The thermocouples reaching temperatures higher than 75°C were TC 10, TC 9, TC 14, TC 8, TC 13 and TC 18 – again indicating roughly uniform heat transfer in all directions of the PV array with adjacent sections. Only a small temperature increase was observed in the thermocouples beneath the vapour barrier during test 7 as plotted in Figure 17.

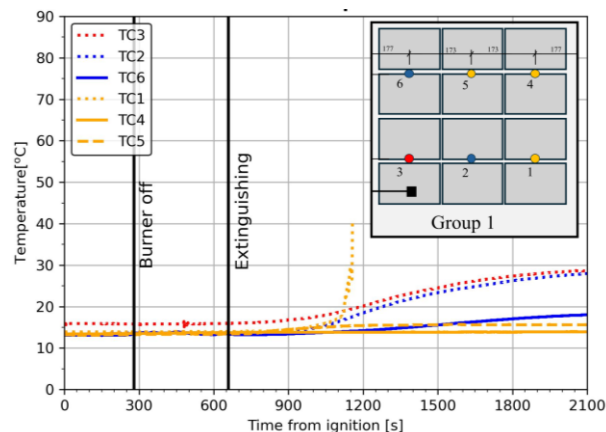
Figure 17 - Thermocouple measurements in test 7 below the vapour barrier (TC group 1).
