LARGE-SCALE TESTS OF  
FLAME-SPREAD ON ROOF  
BUILD-UPS WITH PV  
SYSTEMS: PHASE III

03/2026

**Case number:** SIEC21006  
**Report number:** 21006-001  
**Prepared by:** J. S. Kristensen, PhD jsk@dbigroup.dk  
**Approved by:** A. Frost-Jensen, Director of afj@dbigroup.dk  
 Infrastructure & Quality

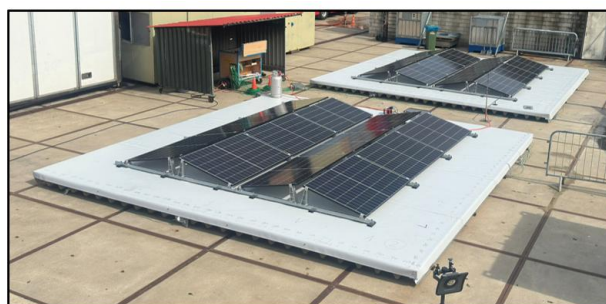
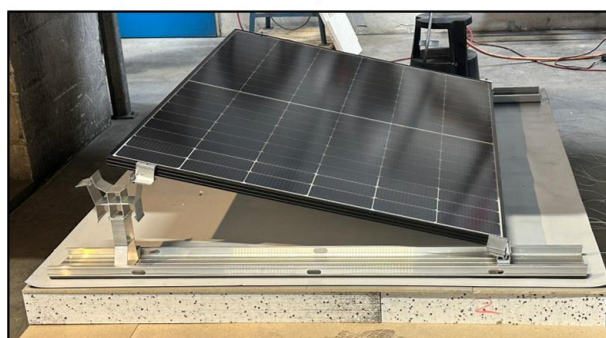
Figure 1 – **a)** Aerial view of test 8 and test 9 (closest) in September 2025 at the test area in the Netherlands. **b)** One of the six medium scale tests conducted at DBI’s facilities in Denmark.

The effect of CBP was only tested with a thickness of 12 mm which can represent a substantial load on existing roof construction in addition to the BAPV itself. Thus, the effect of an 8 mm thick CFB from the same manufacturer, as well as a 6 mm thick cement board, are examined in two large-scale tests similar to the previously conducted tests as illustrated in Figure 1a.

In addition, six medium scale tests with a single PV module were conducted at the facilities of DBI as seen in Figure 1b. The roof construction build-ups and BAPV system of the medium scale tests were similar to the two large-scale tests presented herein and all tests conducted with the PVC membrane in the phase I and II reports [5], [6]. The objective of the tests was i) to eliminate the influence of ambient parameters and ii), to verify the findings from the large-scale test.

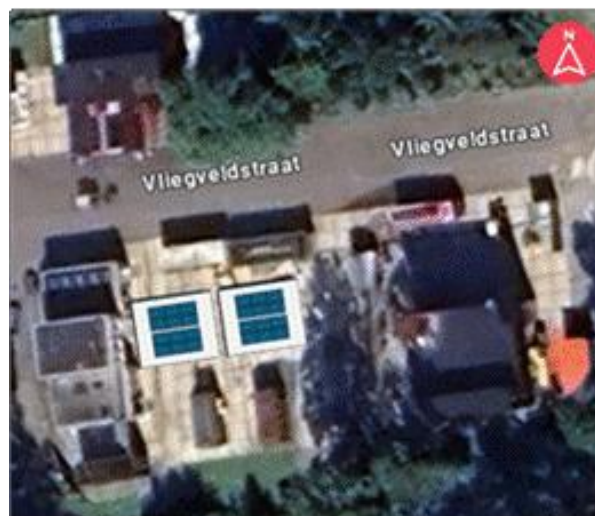
Figure 2 – Test location and construction orientation.

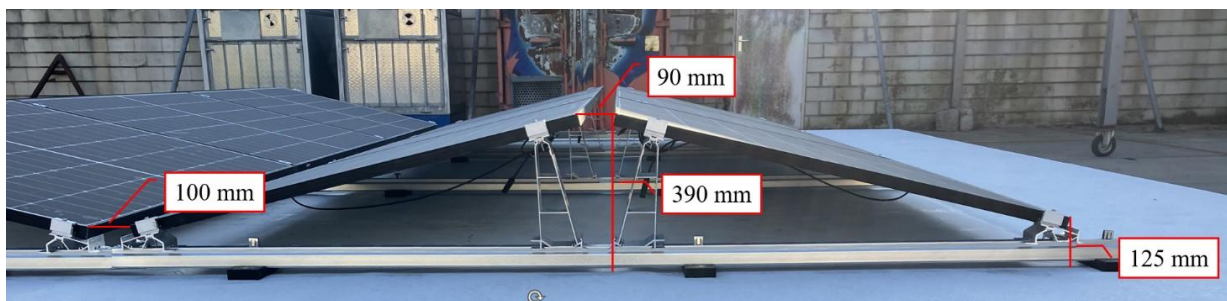
Figure 3 – Partial side view of the East/West-orientated PV array. The distances between the lower edges of the two array sections, the upper edges of the modules, as well as the distances from the PV modules to the roof surface are all measured from the top of the module frames. The same mounting system and PV modules were used across all large-scale tests as well as phase I and II off this project from where the illustration originates [5-7].

Throughout all tests the same type of PV module, a LYNUS M19N TOPCon TYPE MONO LY430 Wp, were used. The backside of the monofacial PV module was a plastic based foil. Due to availability, two different mounting systems were used in respectively the large- and medium scale tests as seen from the side view in Figure 1b and Figure 3.

The different mounting systems across the large- and medium scale tests rendered two different cavity geometries between roof surface and PV modules. With the gap distances being defined as the distance between roof surface and the upper edge of the PV module’s frame, the gap heights in the large-scale tests were between 125 mm and 390 mm, whereas there was 80 mm and 345 mm between the roof surface and the lowest and highest part of the PV modules. As such, the inclination remained constant across all tests. However, the gap height in the medium-scale tests was 40 mm lower than in the two large-scale tests in this report and the seven tests presented in the phase I and II reports [5], [6].

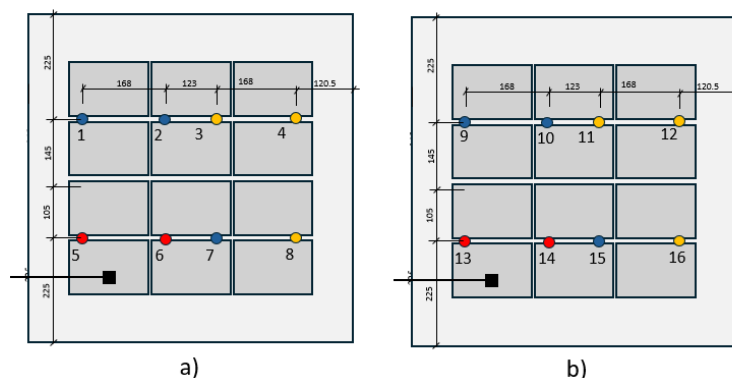
Figure 4 – Sectional top view sketch of large-scale tests 8 and 9. Location of PV modules (dark grey rectangles), gas burner (black square on the lower left) and thermocouples which are numbered and colour coded for later use. **a)** between layers #6 and #5 in accordance with Table 1, **b)** between layers #5 and #4 in accordance with Table 1.

As indicated by the red dots in Table 1 and sketches in figure 4, a total of 16 type-k thermocouples (TCs) were installed in each of the large-scale tests. Due to expected limited flame spread in the two tests, compared to the previous seven large-scale tests [5], [6], the number of TCs was

reduced. In each test, half of the TCs were installed between the PVC membrane and mitigation layer, whereas the other half were installed below the mitigation layer and thus on top of the EPS insulation as per Table 1.

With TC5 and TC6 being the thermocouples installed closest to the ignition source (figure 4a), but outside the footprint of the PV module below which the ignition source was located, significant temperature increase would indicate self-sustained flame spread. Thus, the location of the thermocouples in the two large-scale tests provided limited data quantifying heat transfer near the location of the ignition source.

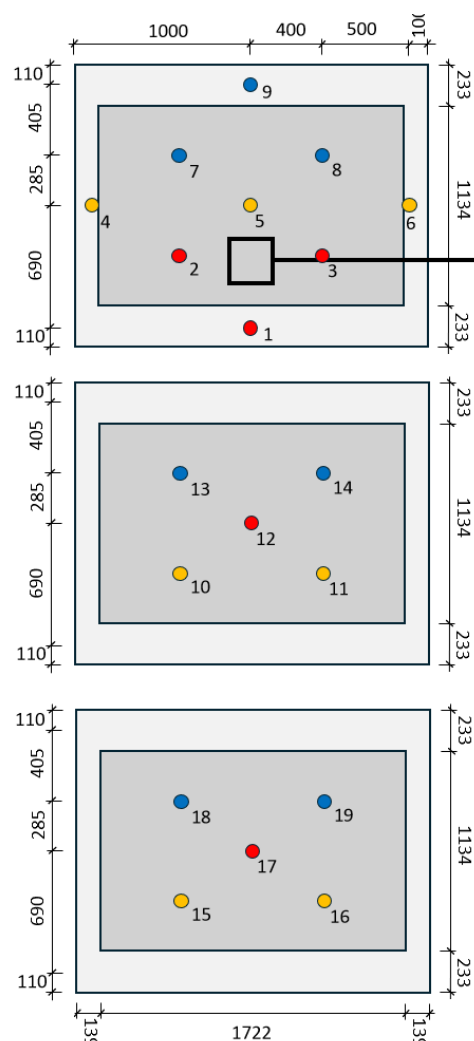
Figure 5 – Location of thermocouples (TCs) in the medium scale tests. The dark grey rectangle and black square indicate the location and dimensions of respectively the PV module and the gas burner. TC1-TC9 were installed between layers #1 and #2, whereas TC10-TC19 were installed in accordance with Table 2.

Contrary to the thermocouple density in the large-scale tests, a total of 19 TCs were installed in each of the medium scale tests. As seen from the TC locations in Table 2 and Figure 5, nine TCs were installed between the PVC membrane and subjacent insulation, whereas only five TCs were installed between each of the remaining layers. The objective of the additional TCs in the uppermost layer of thermocouples, TC1, TC4, TC6 and TC9, were to quantify potential heat transfer from a fire below the PV module to the near vicinity outside the footprint of the single PV module, whereas the purpose of the remaining TCs was quantification of heat transfer from the roof surface through the roof construction.

In all tests, the square-shaped gas burner was positioned at the midpoint along the width of the single PV module in the medium scale tests. The horizontal distance from the burner's nearest edge to the lower edge of the PV module was 120 mm, while the vertical clearance between the bottom of the burner and the roof construction measured 80 mm.

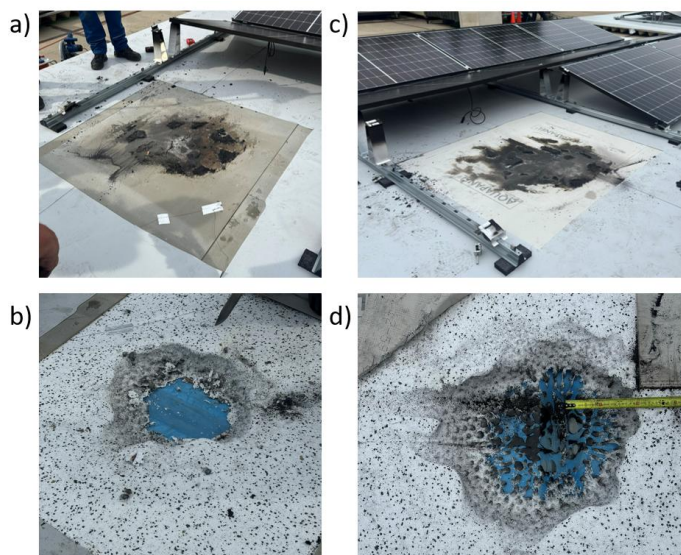
Figure 6 – Visual damage of the mitigation layers, EPS insulation and vapour barrier in large-scale tests 8 (a-b) and 9 (c-d).

In the two large-scale tests, test 8 and test 9 with mitigations layer of respectively the 8 mm cement-bonded particle board and the 6 mm cement board, no self-sustained flame spread occurred outside the domain of the ignition source after the gas burner was turned off after 10 minutes. As such, the fire only affected a single PV module in each test and damaged the areas of the roof sections seen in figure 6a & c.

Similar to previously conducted tests with the 12 mm cement-bonded particle board, the heat transfer from the ignition source melted the EPS insulation directly below the gas burner as seen in figure 6b & d. From inspection of the EPS cavity, there was no indication of a combustion process. It was assumed that the darker spots of the EPS occurred due to concentration of the graphite in the dark EPS beads. In both large-scale tests, the EPS cavities reached temperatures that caused melting and localised holes in the subjacent moisture barrier as visually prominent in Figure 6d.

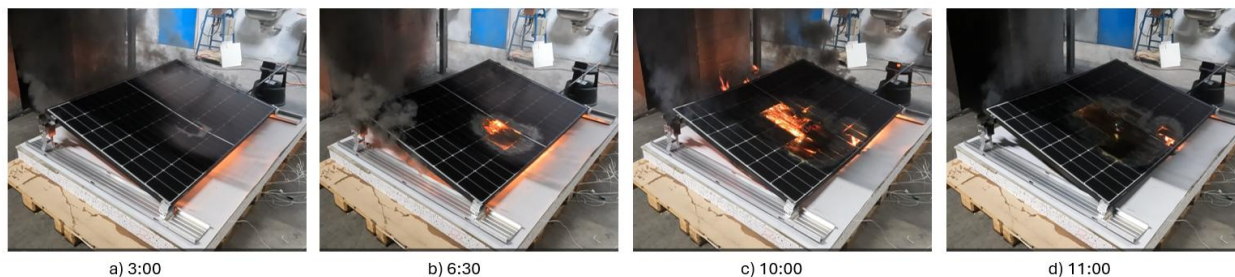
Figure 7 – MT1 with 1.5 mm PVC membrane, 12 mm CBP and 100 mm EPS insulation. Time from ignition in min:sec.

In tests MT1 and MT4, an increase of the HRR is observed near the end of the tests. For MT1, this increase corresponds well with the visual observations in Figure 7c, where the fire has propagated to a larger area of the roof mock-up. The fire self-extinguished 10 minutes after ignition as self-sustained flame spread was not

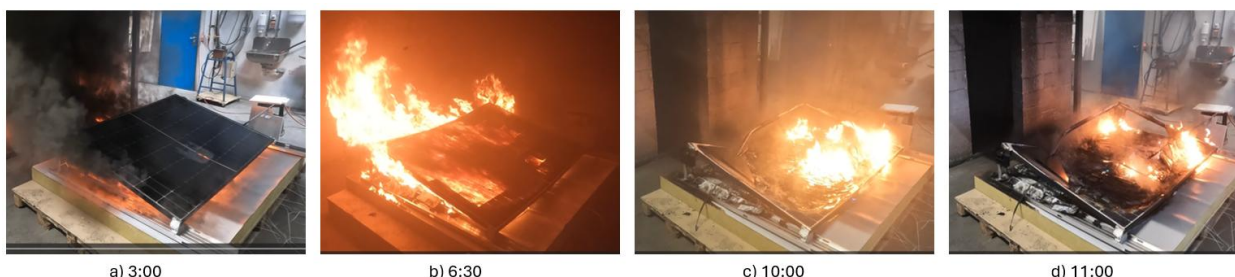
Figure 8 – MT4 with 1.5 mm PVC membrane on top of 100 mm mineral wool insulation. Time from ignition in min:sec.

In MT4, the extraction in the laboratory could not follow the smoke production and the laboratory became full of smoke as seen in Figure 8b-c. 10 minutes after ignition, the laboratory gate was opened to allow additional ventilation of the fire which self-extinguished 14 minutes after ignition. As observed in large-scale tests [8], [9], the fire only propagated below the PV module in the tests with self-sustained flame spread, as the fire did not propagate to the area of PVC membrane in front of the lower PV module edge in Figure 8c. In the repeated test of MT4, MT5, the fire was extinguished with water 5 minutes after ignition to prevent significant smoke spread outside the extraction hood. Consequently, the repeatability of the test method is solely based on the initial 5 minutes after ignition.

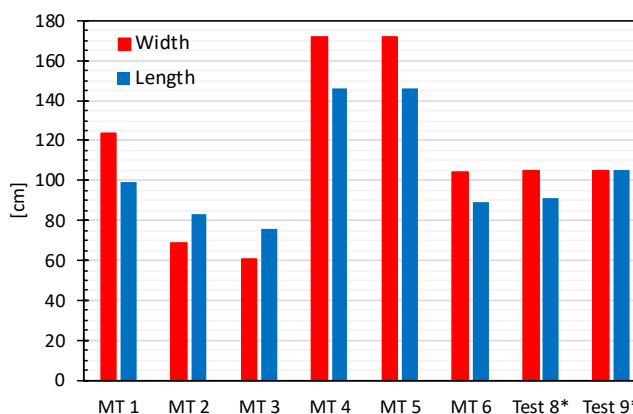
Figure 9 – Damaged area of the PVC roofing membrane in the six medium scale tests, MT1-6, and two large-scale tests, test 8-9.

Considering the width and length of the damaged PVC membrane area in the two large-scale tests and six medium scale tests, plotted in Figure 9, a distinct effect of the cement based mitigation layers is identified. In MT4 and MT5, the damage reaches the maximum dimensions, corresponding to the width of the PV module and the length between the roof area below the lower edge of the PV module and the edge of the roof mock-up closest to the most elevated part of the module, as shown in Figure 10.

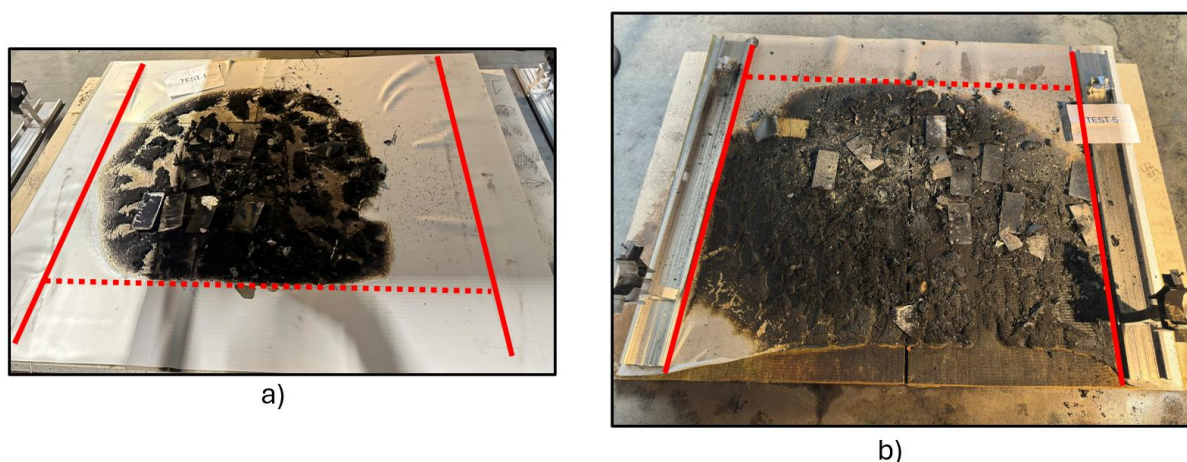
Figure 10 – Damaged area of the PVC roofing membrane in two of the medium scale tests. **a)** MT1 with a mitigation layer of 12 mm cement bonded particle board between the membrane and adjacent EPS insulation. **b)** MT5 with the membrane installed directly on 100 mm mineral wool insulation. MT5 was extinguished 5 minutes after ignition due to smoke production. Note that the two images were taken from different sides of the roof mock-ups. The dotted red line indicates the location of the PV modules lowest edge, whereas the solid red lines indicate the edge of the mounting systems.

The trends identified in the visual observations and HRR measurements of the medium scale tests repeat themselves when looking at the temperatures measured between the PVC membrane and the subjacent materials. First of all, the initial parts of the two repeated tests with mineral wool and no mitigation layer, MT4 and MT5, are near identical as seen in Figure 14. In addition, the limited temperature increase of TC1 verifies that the fire did not propagate outside the lowest edge of the PV module and thus outside the cavity between the module and roof surface as visually observed in Figure 10.

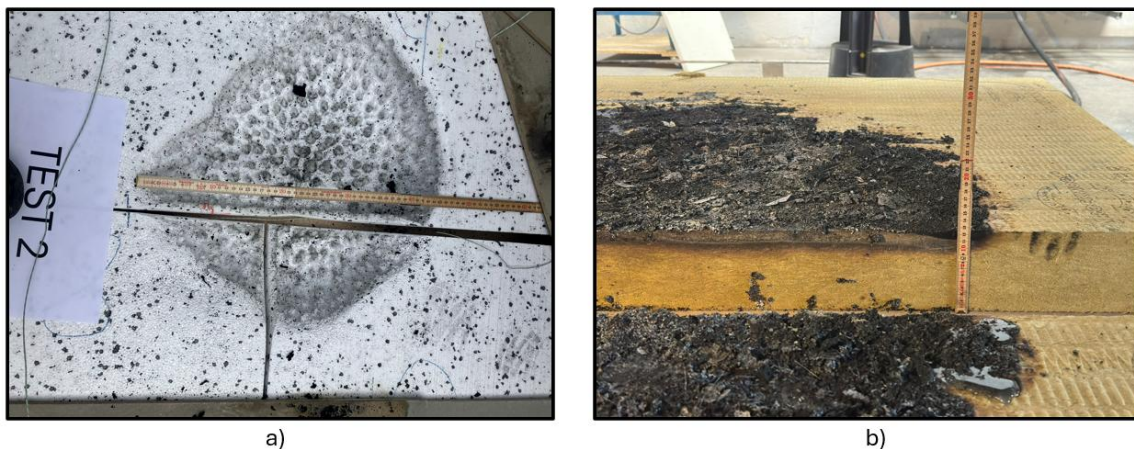
Figure 11 – Damage of the insulation materials. **a)** MT2 with a mitigation layer of 8 mm cement bonded particle board between the membrane and subjacent EPS insulation. **b)** Side view of the mineral wool insulation in MT5 where the membrane was installed directly on 100 mm insulation at the location of the gas burner. MT5 was extinguished 5 minutes after ignition due to smoke production.

Although the fire did not propagate in the tests conducted with any of the mitigation layers installed on top of the EPS insulation, the energy from the ignited area of PVC membrane, as well as heat transfer from the gas burner, did affect an area of EPS directly below the ignition source as seen from figure 11a.

Similar to the damaged EPS insulation, the mineral wool insulation was also affected by the heat transfer from the fire between the PV module and roof surface as seen from the extinguished MT5 in figure 11b. Unfortunately, no similar side view image was taken of test MT4, but based on previously conducted tests with flame spread below BAPV systems installed on roof built-ups with a PVC membrane and mineral wool insulation, more severe thermal damage would be expected [14], [15].

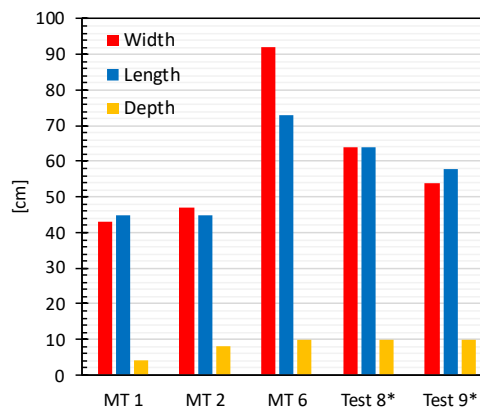
Figure 12 – Dimensions of the EPS void in the three medium and two large-scale tests conducted with mitigation layers between the PVC membrane and 100 mm thick EPS insulation. **MT1:** 12 mm CPB, **MT2 & Test 8:** 8 mm CPB, and **MT6 & Test 9:** 6 mm cement board. \*Based on measurements by KIWA BDA.

Dimensions of the EPS voids below the location of the gas burner in medium and large-scale tests are plotted in Figure 12. In general, the width and length of the damaged EPS insulation were smaller than the corresponding damage of the PVC membrane in Figure 9, with the medium scale test conducted with the 6 mm cement board being the sole exception.

Comparing the medium and large-scale tests with respectively the 8 mm cement-bonded particle board (CPB) (MT2 & Test 8) and 6 mm cement board (MT6 & Test 9), two observations can be made: i) the depth of the EPS void were significantly higher than in the test with the 12 mm CPB and reached the maximum of 10 cm in three of four tests. ii) based on the limited number of tests, no consistent relationship was identified between the medium- and large-scale results.

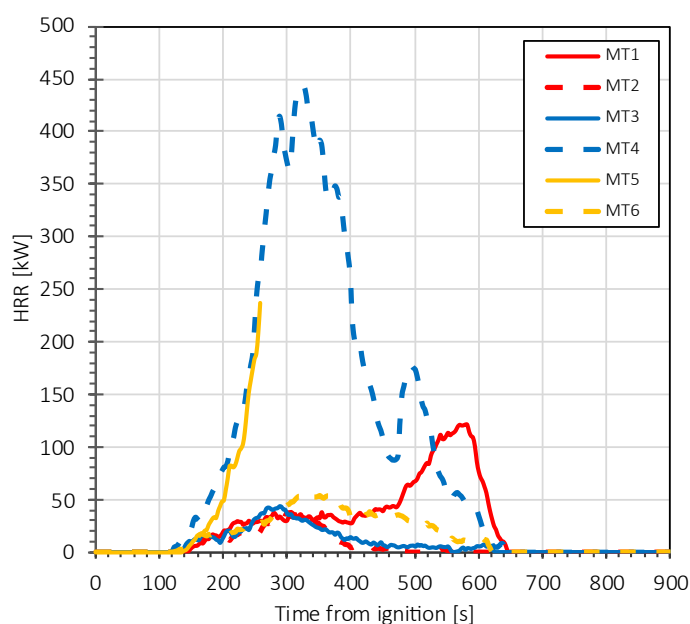
Figure 13 – Heat release rate (HRR) measured during the six medium scale (MT) tests. Note: MT5 was extinguished 5 minutes after ignition due to smoke production.

From the heat release rates (HRR) plotted in Figure 13, the two trends from the visual observations are verified as significantly higher HRR were measured in medium scale tests 4 (MT4) and 5 (MT5), being the two tests with no mitigation layer between the PVC membrane and subjacent mineral wool insulation. In addition, the HRR measurements of the two repeated tests also indicate a decent repeatability of the tests, until MT5 was extinguished.

The repeatability of the test method is also evident when comparing the HRRs measured in the two tests with an 8 mm thick cement-bonded particle board used as a mitigation layer between the PVC membrane and, respectively, the EPS (MT2) and mineral wool (MT3) insulation. Similar to the damaged area of the PVC membrane shown in Figure 9, the outcomes of the two tests are nearly identical. This indicates that the thermal properties of the insulation are less important when the test is conducted with this specific PVC membrane and mitigation layer.

possible without the additional heat transfer from the gas burner which was switched off. In the MT4, the timing of the second peak corresponds to the breakage of the PV module's glass front, which allowed additional oxygen to enter and exposed additional fuel from the polymeric laminates used in the PV module.

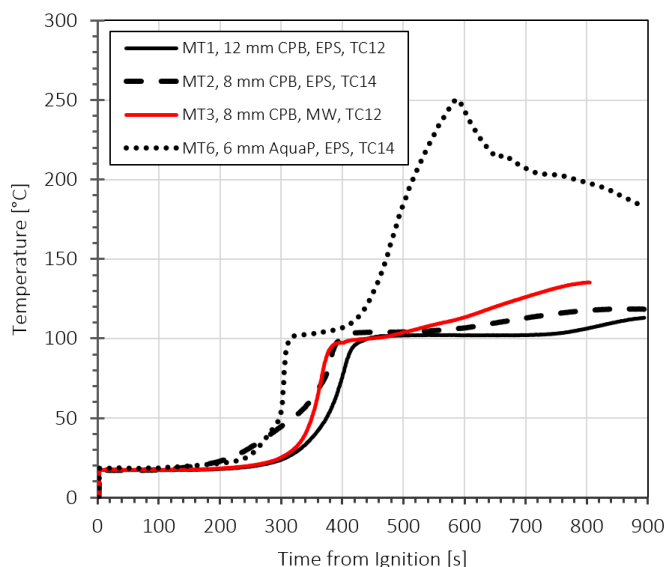
Figure 17 – Temperature measurements between the mitigation layer and subjacent EPS insulation (MT1, MT2 & MT6) or mineral wool insulation (MT3) at the location of either TC12 or TC14 in accordance with figure 5.

The thickness, mass and thermal parameters of the mitigation layer also influenced the heat transfer from the fire, through the mitigation products and towards the insulation materials. Comparing the highest temperatures measured below the three mitigation solutions between the PVC membrane and EPS insulation, three things are noticed in Figure 17: i) In all three tests, a plateau was reached around 100 °C, ii) the plateau was reached faster for the thinner mitigation layers, and iii) the time duration of the plateau was shorter for the thinner materials.

With all three mitigation layers being based on cementitious composite products, it is expected that the plateau is linked to the chemically bound water within the product. Due to the high specific heat of water, the

bound water served a buffer during the initial phase of the heating, absorbing significant amounts of energy and thus preventing heat transfer to the subject insulation materials. As soon as the water was vaporised, heat transfer through the mitigation layers were based on the conductivity of the thermally altered materials.

Comparing MT1 and MT2 with mitigation layers of respectively the 12 mm and 8 mm cement-bonded particle board (CPB), the temperature of the thinner product increases faster, as seen in Figure 17, due to the lower areal mass. In addition, the thickness affects the secondary temperature increase which was initiated around 750 and 550 seconds after ignition for MT1 and MT2.

Comparison of the temperatures between the mitigation layers and EPS also indicate that other thermal parameters than the thickness might be different between the cement board and the Cement-bonded particle boards (CPB) as the plateau was reached faster and a significantly higher peak temperature was reached. However, it is acknowledged that the high temperature of 250 °C can also be due to a more direct contact between the thermocouple and backside of the mitigation material after the EPS has melted.

Finally, the faster secondary temperature increases below the mitigation layer in MT3 with mineral wool insulation, compared to MT2 with the same mitigation layer on EPS insulation illustrates that the upper part of the mineral wool isolates significantly better than the gradually growing void of melted EPS.

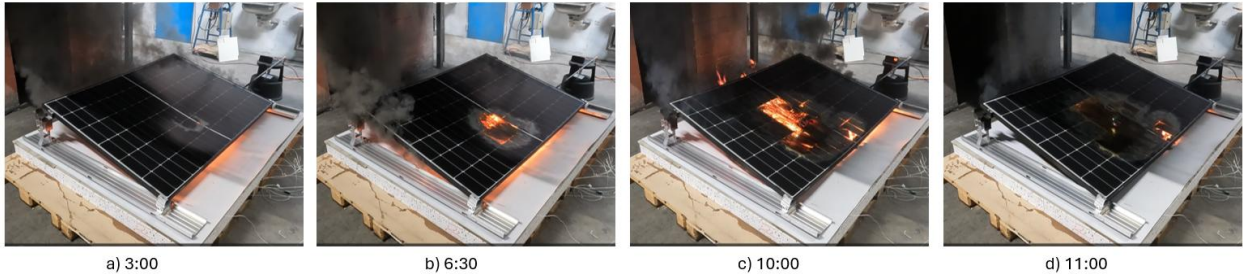
Figure A 1 – MT1 with 1.5 mm PVC membrane, 12 mm CBP and 100 mm EPS insulation. Time from ignition in min:sec.

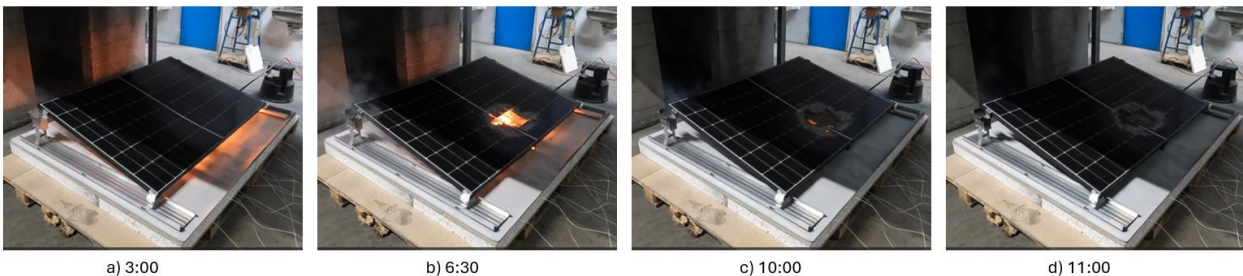
Figure A 2 – MT2 with 1.5 mm PVC membrane, 8 mm CBP and 100 mm EPS insulation. Time from ignition in min:sec.

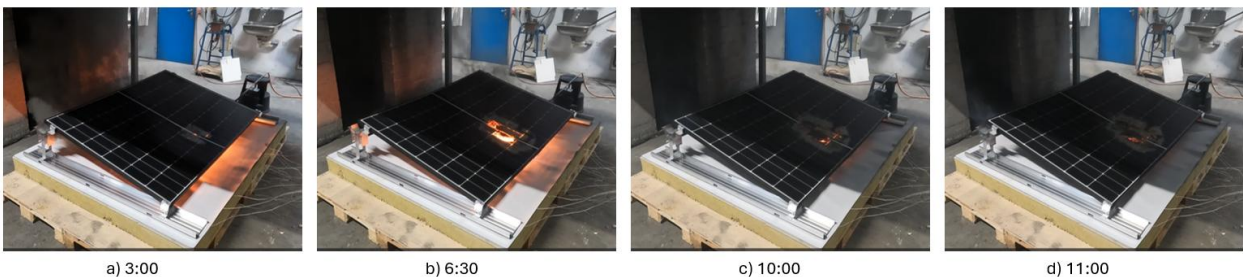
Figure A 3 – MT3 with 1.5 mm PVC membrane, 8 mm CBP and 100 mm mineral wool insulation. Time from ignition in min:sec.

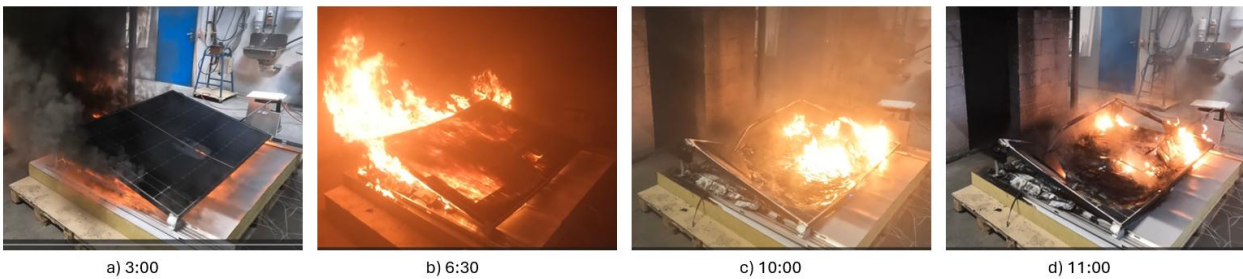
Figure A 4 – MT4 with 1.5 mm PVC membrane on top of 100 mm mineral wool insulation. Time from ignition in min:sec.

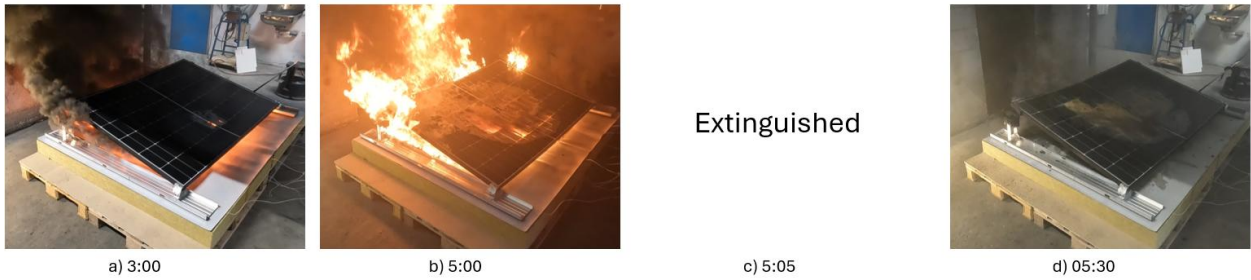
Figure A 5 – MT5 with 1.5 mm PVC membrane on top of 100 mm mineral wool insulation. Time from ignition in min:sec.

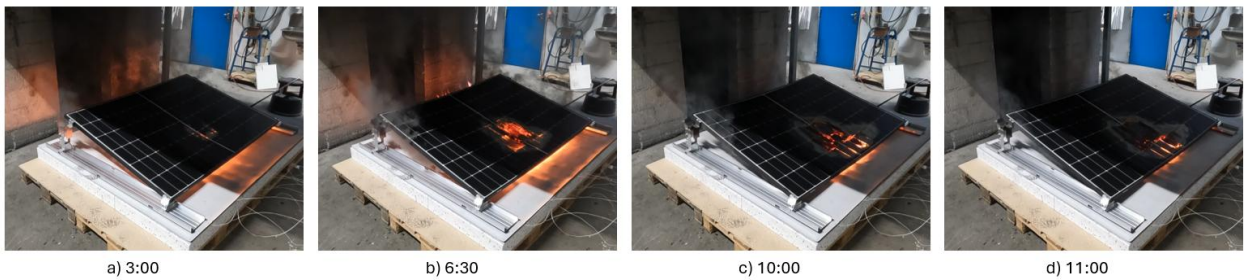
Figure A 6 – MT6 with 1.5 mm PVC membrane, 6 mm cement board and 100 mm EPS insulation. Time from ignition in min:sec.
