LARGE-SCALE TESTS OF FLAME
SPREAD ON ROOF BUILD-UPS
WITH PV SYSTEMS: PHASE I

11/2025

Case number: SIEC21006
Report number: 21006-001

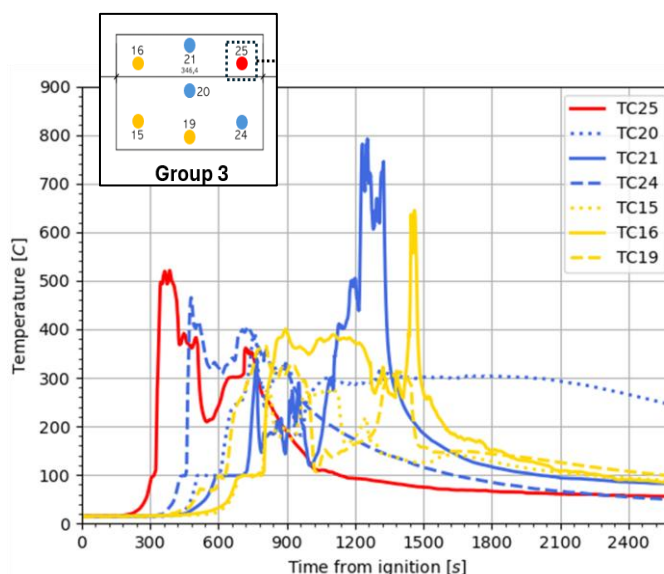
While in tests 2-4 two different TC groups were placed above and below the mitigation layer (TC Group 3 and 2 respectively), test 1 was characterized by the presence of an individual TC Group positioned beneath the glass-fleece layer only. Figure 18 shows the temperature development for TC Group 3 of test 1. An understanding of both flame spread across and into, the roof construction for test 1 can be inferred from these measurements.

Due to its proximity to the burner and placement corresponding to the ignition location, TC25 is the first TC to record a significant temperature increase due to heat transfer from the gas burner and radiative re-radiation from the deflected flame below PV1 (see Figure 5) onto the roof construction.

Thereafter, the flame spread across the roof can be understood by looking at the different onset times of the remaining thermocouples and by observing 1st peak in the temperature curves of Figure 18 and Figure 19. After ignition of the PVC membrane beneath PV1, the fire spreads to the cavity below PV2 and the temperature measured by TC24 increases consequently, which corresponds to the flame spread pattern in Figure 7.1-2. Transition to the adjacent areas of the roof follows as intermediate TC19-21 placed in the middle of the array between PV1-PV2 and PV3-PV4 start increasing simultaneously. Finally, once the flame spread reaches PV3 and PV4, the temperatures of TC15 and TC16 increase.

Figure 18 – Temperature development measured in between the glass-fleece and EPS insulation measured by TC group 3 in test 1. Location of the individual TCs marked in the upper left corner in correspondence with Figure 6.

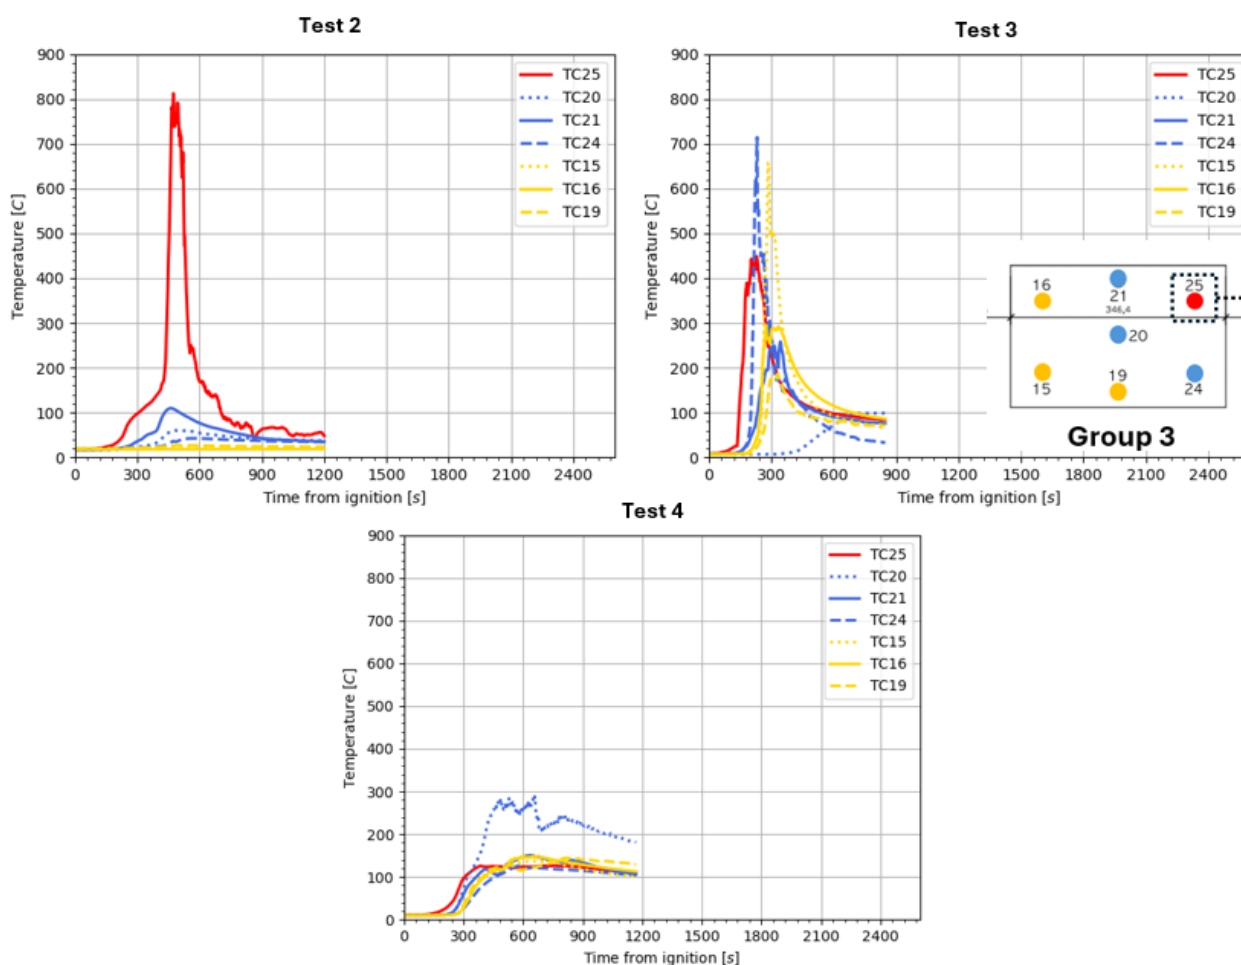
Contrary to test 1, tests 2, 3 and 4 share the same TC Group placements within the construction layers, allowing a more straightforward comparison between the temperature measurements. Above all, differentiation in the flame spread across and into the roof can be made more distinctively. Namely TC Group 3, placed between the roof membrane and the cement-bonded particle board, can be utilized for the analysis of the fire spread; TC Group 2 positioned below the cement-bonded particle board highlights the heat transfer into the subjacent roof construction. Similarly to what was seen in Figure 18 for test 1, the thermocouples positioned as TC25 were the first to record a temperature increase in tests 2-4 due to its immediacy with the ignition source, as seen in Figure 19.

As flame spread only occurred along the area below PV1 in test 2, it is reflected by the temperature measurements, where only TC25 and the adjacent TC20 and TC21 monitor significant temperature increases. On the contrary, all thermocouples installed in the layer closest to the roof surface, TC Group 3, measure significant temperature increases, which corresponds to the flame spread patterns seen in Figure 8 and Figure 9. The increased flame spread rate, most likely facilitated by the slightly higher wind load, can be observed by the shorter thermocouple activation times compared to those from tests 1 and 2. Similarly to test 1, similar flame spread dynamics across the roof are seen in test 3 and test 4 where TC24 activates as the fire spreads below PV2, followed by the TCs placed in the middle of the roof and ending with the thermocouples placed below PV3 and PV4.

Figure 19 – Temperature development measured by thermocouples (TC) installed below roofing membrane (TC Group 3) in tests 2,3 and 4. Location of the individual TCs outlined in lower right side of the plot for test 3 (upper right), in correspondence with Figure 6.

When comparing tests 2 and 3 to test 4, more pronounced temperature dynamics are observed in the former, including rapid temperature rise, a higher peak temperature in the test involving self-sustained flame spread beneath the PV array (test 3), and a faster post-peak temperature decay. This behavior contrasts markedly with the slower temperature development and near-steady-state condition observed in test 4. The pronounced differences are ascribed to the material parameters of respectively the 1.8 mm thick PVC membrane in tests 2-3 and the 8 mm thick dual-layer Bitumen-based membrane examined in test 4.

In test 4, the significantly elevated steady-state temperature recorded by TC20 (see Figure 19) constitutes an outlier. This anomaly may be attributed to intensified radiative heating at the center of the PV array, potentially followed by upward penetration of the thermocouple through the bitumen membrane, facilitated by an increased thermal degradation of the membrane material.

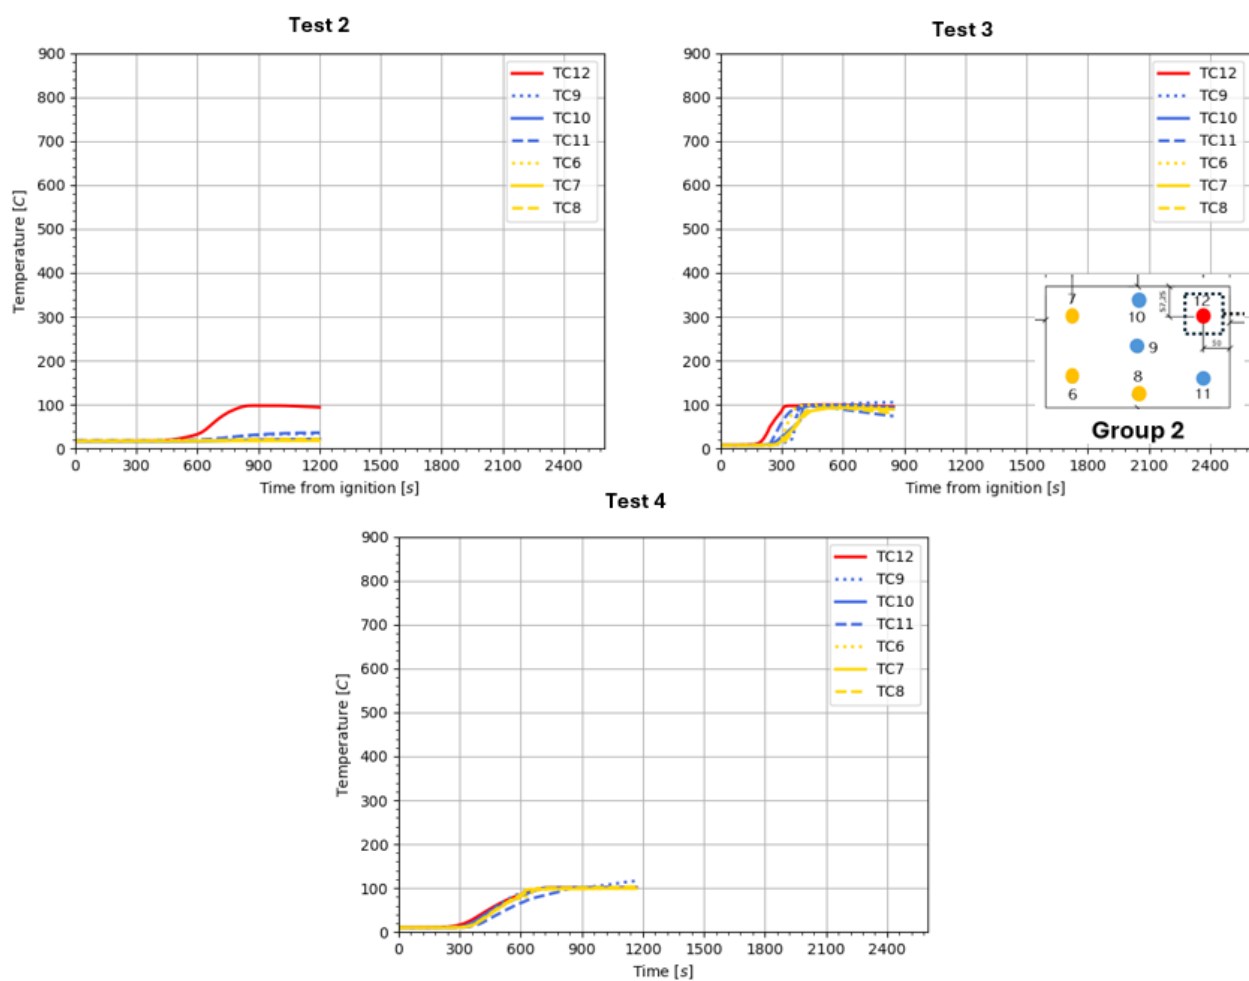
The temperature data from TC Group 2, placed below the cement-bonded particle board, shows how the heat transfer from the surface area, involved in the fire, transitions into the deeper layers of the roof construction build-ups as plotted in Figure 20.

The temperature data from TC Group 2, placed below the cement-bonded particle board, shows how the heat from the roof area involved in the fire transitions into the deeper layers of the construction. In test 2, since the fire spread was limited to PV1, only TC12 installed subjacent to the heated area was affected, measuring a maximum temperature of 95°C. For tests 3 and 4 instead, all TCs in Group 2 increase as the fire propagates along the roof surface below the BAPV array. In those tests, maximum temperatures of 100°C were reached and maintained until the end of the test. These temperature measurements may be the result of water vapour

Figure 20 – Temperature development measured by thermocouples (TC) installed below cement-bonded particle board and EPS insulation (TC Group 2) in Tests 2,3 and 4. Location of the individual TCs outlined in lower right side of the plot for test 3 (upper right), in correspondence with Figure 6.

released from the cement particleboard caused by the heating process from the fire, especially since cement-bonded particle board is characterized by an inherent stored water content around 10 % [17].
